# Technical *Info*

## Retooling the tensioning technology in the Ford 1.8 diesel ( CT 983 K1/K2 )

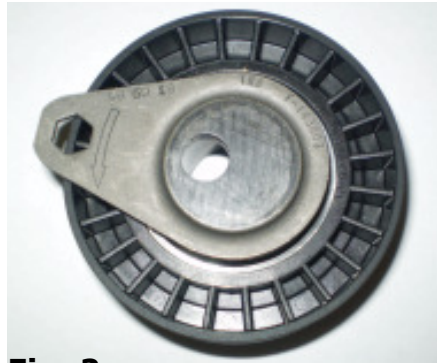
The tensioner pulley in the kit is designed technically differently from how it is installed at the factory.

**Fig. 1**  
**Type to be replaced**

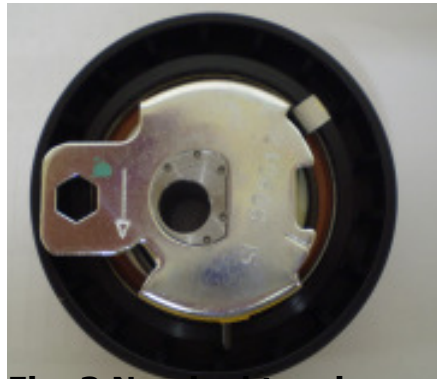
**Fig. 2**  
**New tension pulley technology**

The new type is a semi-automatic tension pulley which is installed centrally in place of the manual tensioner (50 Nm). Following installation of the timing belt, as normal, the tension is adjusted on the disc on the front by turning it in the imprinted direction of the arrow using an Allen key. Make sure that the recess is opposite the stop lug in approx. 3:00 position. In some older versions, the cover must be filed by a few tenths of a millimeter in the area of the tensioning roller.

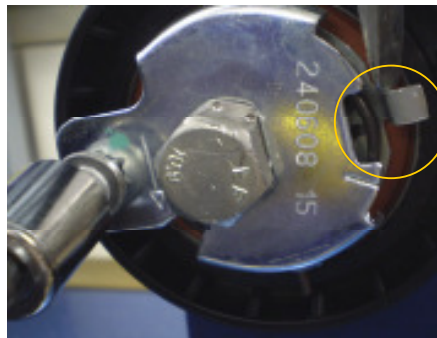
**Fig. 3 Nominal tension**
