VAG engines: 1.6 TDI, 2.0 TDI
(EA288 engine)

VKM 11278

Case study VAG TDI engine, 1.6 TDI, 2.0 TDI (EA288 engine)

Problem: broken tensioner back plate / broken tensioner spring – VKM 11278

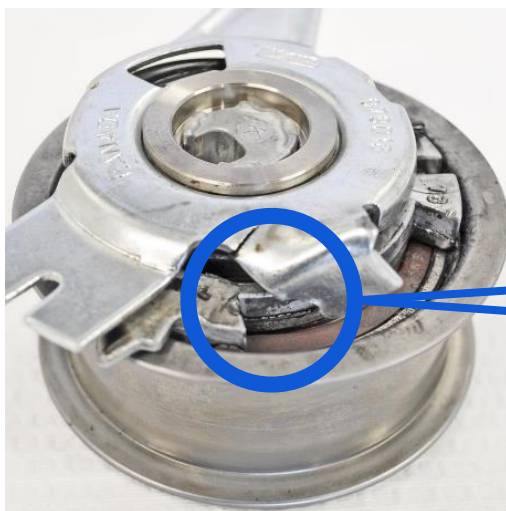
The back plate is severely deformed and torn.

During the inspection, we did not find any signs of a material or manufacturing defect on the components. The tensioner shows heavy impact marks with material incorporation on both end stops. The nose of the back plate, which moves between the end stops without contact when the tensioner is set correctly, was severely deformed due to frequent and impermissible impact on the end stops.

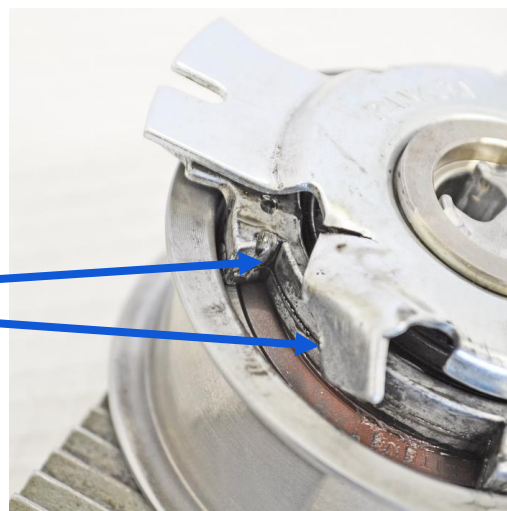
The end stops show deformation.

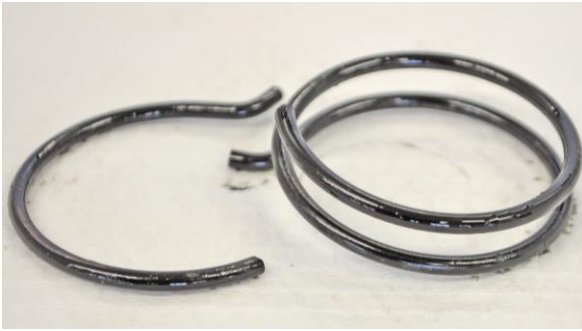
When investigating the tensioning pulley, it is often found that the spring of the tensioning pulley is broken or has jumped out of the fixation.

- Spring breakage due to abnormal tensioner oscillation.
- Spring breakage due to abnormal operating conditions with high torsional vibrations, caused by incorrect installation.
