## febi 39888, 39890 45931, 102278

Insert shaft

**To Fit:** Volkswagen Transporter T5

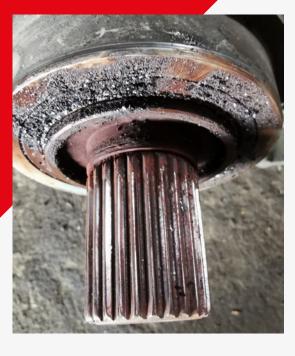
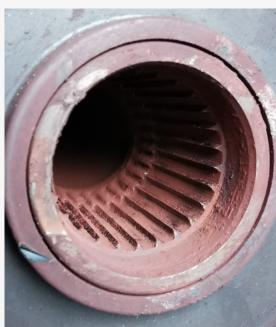
The clonking noise - or loss of drive - is due to the excess wear between the connecting splines of the right insert shaft and the driveshaft. With the vehicle raised, inspect the area of the right-hand driveshaft. Rust stains can usually be found between the insert shaft and the driveshaft due to a lack of lubrication. As a result, the splines of the shafts will have become very worn and will no longer mesh together to drive the wheel.

Example pictures below of the worn driveshaft and insert shaft.

Drain the transmission oil and remove the right-hand front wheel. Remove the worn driveshaft and inspect.

Using a suitable counter hold tool - to stop the insert shaft from turning - loosen the retaining bolt.

Remove the insert shaft from the transmission and inspect for any broken parts (Note: it is common for the brass ring to fracture causing remains to be left inside the differential). Remove all broken metal fragments, as necessary, then remove the driveshaft oil seal.

Apply a high temperature multi-purpose EP grease (21909) to the new seal, filling the space between the sealing lips before installing. Once installed, insert the new insert shaft into the transmission and tighten the retaining bolt to 25 Nm (5-Speed 02Z Transmission) or 35 Nm (6-Speed 0A5 Transmission) using a suitable counter hold tool.

Apply a high temperature multi-purpose EP grease to the mating surfaces of the insert shaft and driveshaft. Then install the new driveshaft assembly and tighten all fixings to the manufacturer's recommended tightening settings.
