FWD Ford Transit, Tourneo
Engine 2.2-litre TDCI Duratorq

Crankshaft Pulley

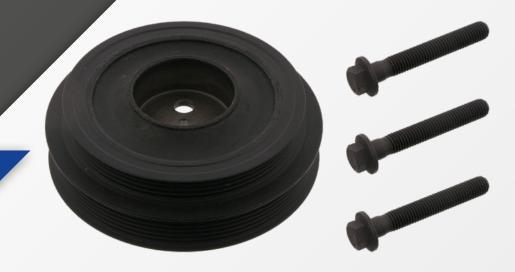
Typical problems include: Abnormal noise and vibration from the timing belt area; Alternator warning lamp illuminated; Power steering belt damaged or has come off the pulley.

Over time, water and road debris ingress into the torsional vibration damper crankshaft pulley, causing premature wear and the failure of the crankshaft pulley and auxiliary drive belt system.

Replace the crankshaft pulley with SWAG 50 93 6626 which includes all of the necessary bolts. All damaged or worn auxiliary drive belts should also be replaced.
