### Lack of power, loud noises, heavy smoke development increased bearing clearance, oil leakage at turbocharger

**Vehicle:** 1.9 JTD, 2.4 JTD

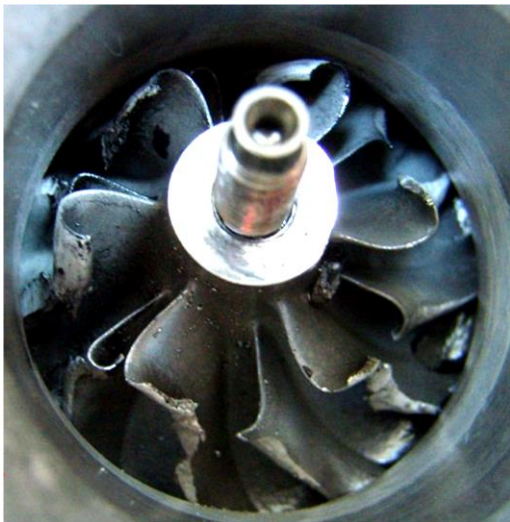
Major accumulations of impurities in the internal engine oil circuit cause clogging of the oil strainer in the banjo bolt of the oil supply line on the engine block. As this strainer becomes progressively saturated, the oil flow rate and oil pressure at the turbocharger bearing points are reduced.

A clogged screen in the banjo bolt leads to premature turbocharger damage due to insufficient lubrication.

The oil inlet and outlet lines must be replaced with the appropriate fittings. If the rotor shaft nut is missing from a damaged turbocharger, it must be located in the air intake system and removed.

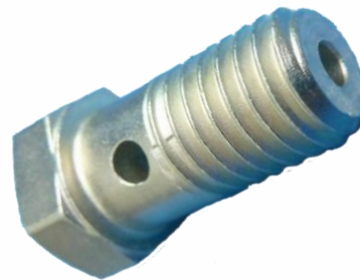
Banjo bolts without strainer are now being installed
