**Weak performance and whistling noises right after the installation of the turbocharger**

This service information is valid for the exchange of the turbocharger with **BTS reference:** T912016; T912016BL; T914750; T914750BL / T931118ABS

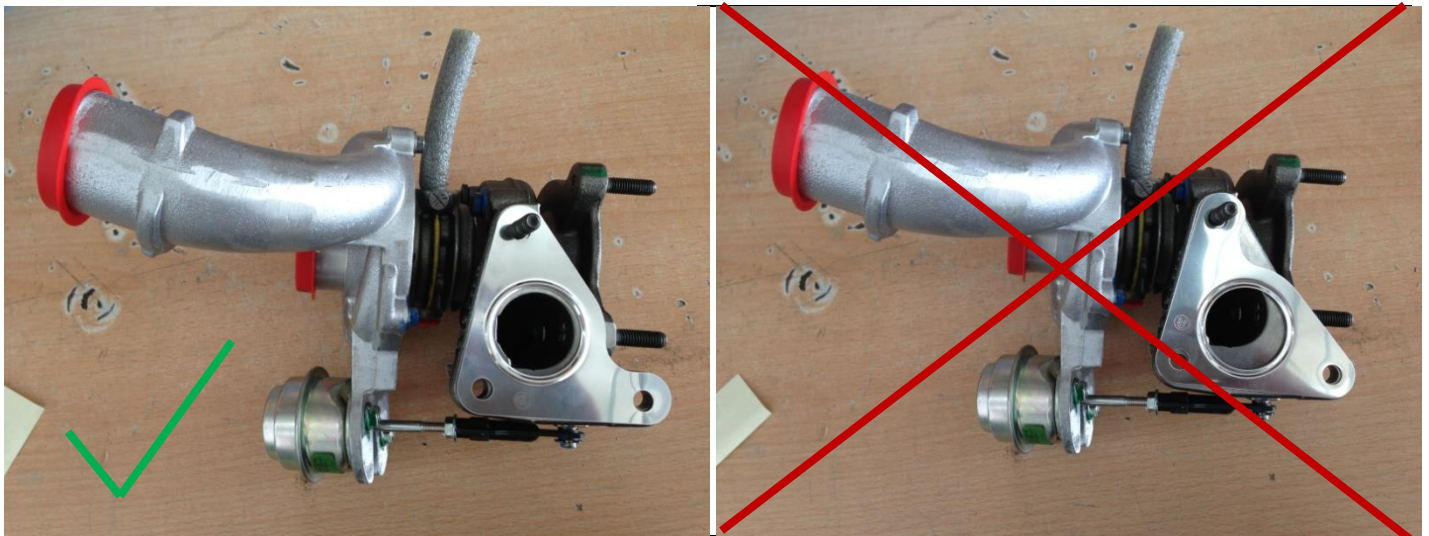
It can easily be mounted in the wrong position, see right picture. That will lead to loss in performance and whistling noises.

When installing this turbocharger, please pay close attention to the gasket between turbocharger and exhaust gas manifold!
