SI-170221

Service-Information Turbocharger

Whistling noises on turbocharger caused by frozen crankcase ventilation

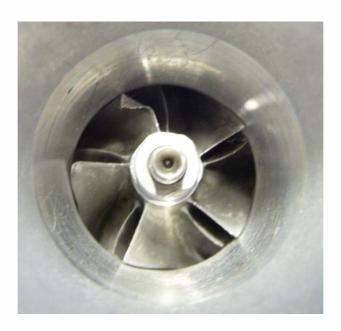
More and more customers have been claiming whistling noises on this turbocharger. In most cases, a damaged compressor wheel is causing those noises caused by foreign bodies in the air inlet duct. Single bent up vanes on the compressor wheel indicate a soft foreign body, e.g. ice lumps in cold temperatures.

When starting the cold engine, condensed water is mixed with oil vapor. This mixture is accumulating in the crankcase ventilation pipes. This accumulation starts lumping and freezing as soon as the engine is turned off. With the engine warming up again, the frozen water-oil-lumps are dissolving and sucked in by the compressor wheel. Those parts lead to the already mentioned soft foreign body damage on the compressor wheel.

Please check all pipes and components of the crankcase ventilation for damages or dirt and clean or fix them thoroughly.

We suggest to use the upgrade offered by the manufacturers to install a heatable crankcase ventilation.
