### Boost pressure loss at full-load operation Screw on intake manifold broken

**Vehicle Manufacturer:** Mercedes

**Vehicle:** Sprinter, Vaneo, Vito

**Engine code:** OM646.986, OM951.955, OM951.xxx

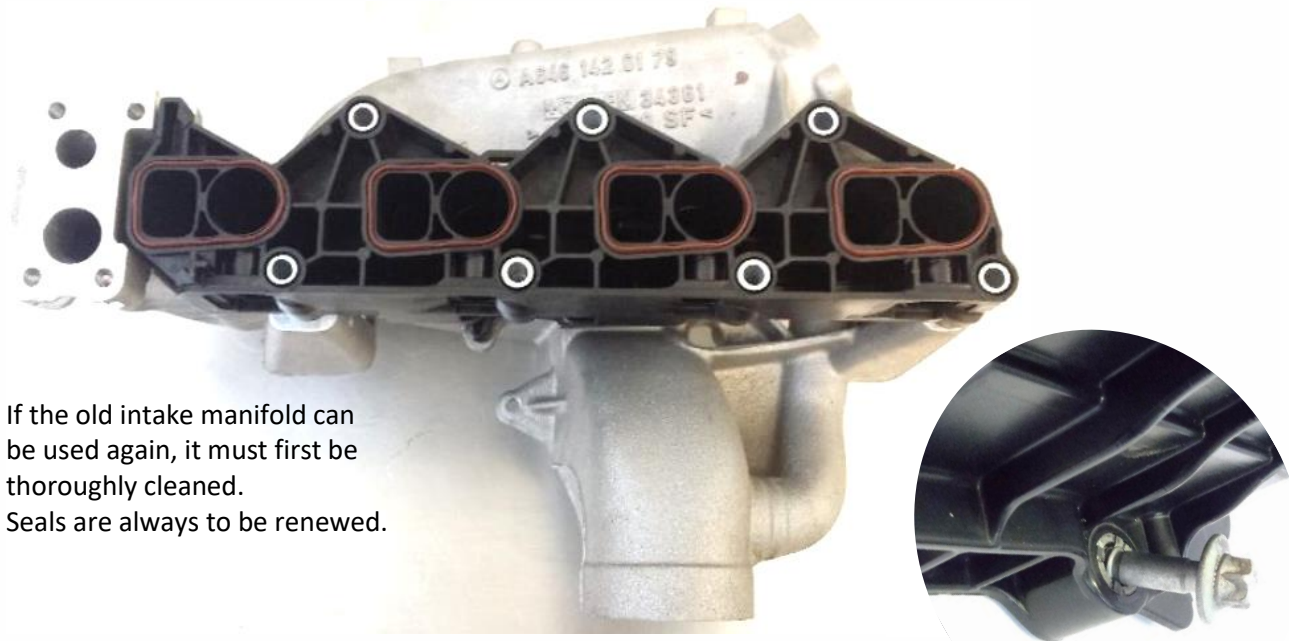
Tricky here is the intake manifold. One or more screws tear on the underside of the intake manifold to the cylinder head. At this point, supercharger pressure escapes.

Check all screws for tightness and completeness. If screws are missing, check the seals of the intake manifold. Overheating due to excessively open EGR valves or excessive exhaust gas back pressure can deform the plastic parts, so check the component for distortion.

When mounting, tighten the screws according to the manufacturer's instructions.

If the old intake manifold can be used again, it must first be thoroughly cleaned.  
Seals are always to be renewed.
