Loss of power and noise due to rupture of Compressor back wall or control rod of the wastegate

Vehicle Manufacturer: Audi, VW, Seat, Skoda

Vehicle: 1.8 TSI/TFSI , 2.0 TSI/TFSI

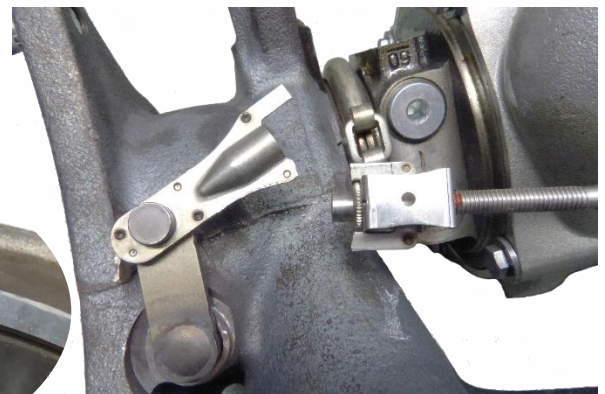
In some cases, noise from the turbocharger and / or loss of power, contrary to known causes of damage, is attributable to breakage of the compressor back wall or the control rod of the wastegate. These are fatigue fractures due to excessive mechanical vibrations from the entire aggregate.

A defective dual mass fly-wheel causes vibrations on the engine that lead to overuse of these components and its rupture. Worn engine mounts amplify the vibrations occurring on the entire unit. This type of damage is not covered by warranty.

Check the turbocharger to be replaced for any damage shown on the rear of the compressor. At least now, dual mass fly-wheel, engine mounts and other factors for vibration have to be checked and, if necessary, replaced.

Also make sure that the pillar is fitted under the turbocharger according to the manufacturer's specifications.
