STARTER REPLACEMENT PROCEDURE – 227012 AND 227012A

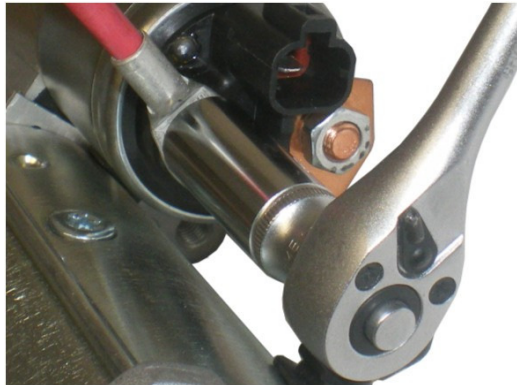
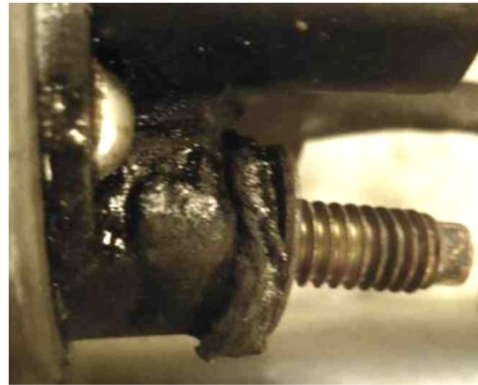
The vehicle CHEVROLET Captiva (Diesel engine 2,2L Z22D1 4 cylinders 16v) is sold with an inadequate size of the battery cable. In normal operation, engines' vibrations can cause tensions along the cable and you may lose the nut. Consequently, abnormal current flow and temperature increase in the connection area can damage battery cable and starter.

- 1) Fix the nut adequately
- 2) If it is necessary, replace the cable with longer one.earth contact.
