# Blue Print ADBP250046

Toyota Prius ZVW30 & ZVW35 models

## Cabin Filter for traction battery compartment

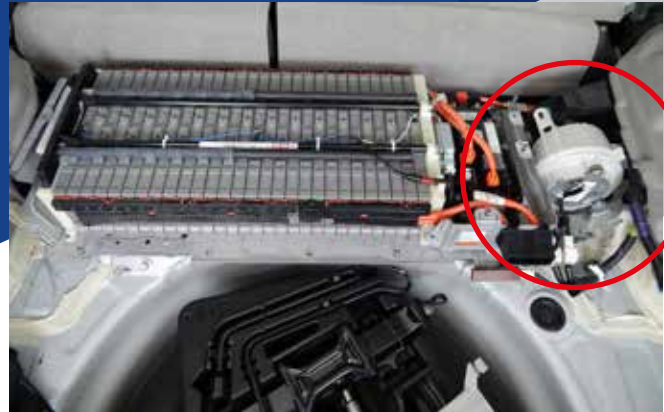
Figure 1.

The most common cause of this problem is the cooling fan becoming blocked by a build-up of dirt and dust from the interior air intake located to the right of the back seat.

The Prius models mentioned above do not have an intake air filter for the high-voltage battery cooling fan fitted as standard. Instead, the fan itself becomes the filter. The fan is located upstream of the battery and collects particulates over time. (Fig.1)

Inspect the battery cooling fan for excess debris. Take off the luggage compartment flooring and right-side trim panel to gain access to the fan module, then remove it from the vehicle and inspect.

Using a vacuum cleaner and compressed air, clear away any dust, lint or debris build-up from the hybrid battery cooling fan blades, control module and air ducts of the hybrid battery cooling system.

Reinstall the hybrid battery cooling fan assembly and verify its normal operation. Repeat this procedure every 15,000 km if the vehicle is used by a lot of back-seat passengers (taxi) or is used regularly to transport pets such as cats and dogs.

It is recommended to install Blue Print filter ADBP250046, which clips over the interior air intake to reduce the build-up of dirt and dust from the interior to the cooling fan. Therefore, reducing the risk of the battery overheating and premature failure.
