IMPORTANT NOTICE

FOR PART A-2780

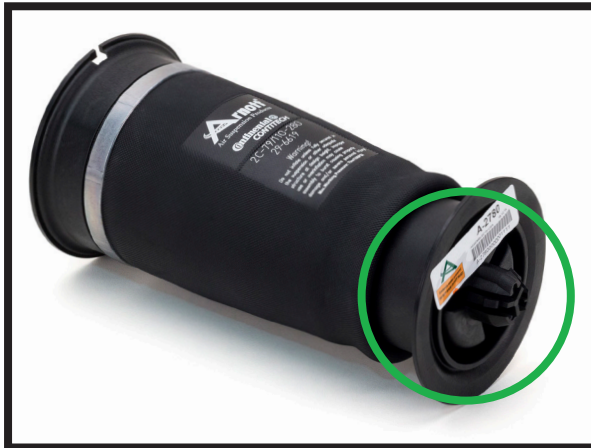
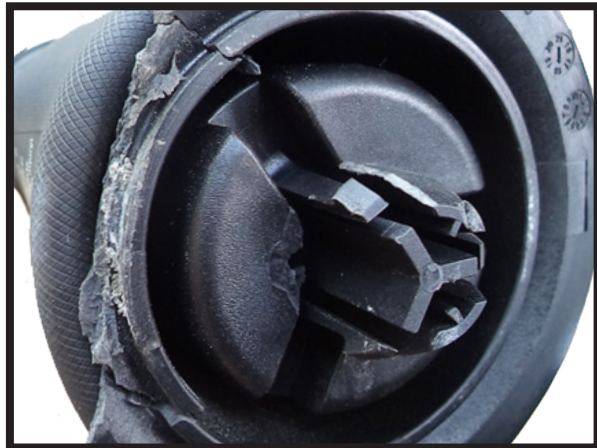
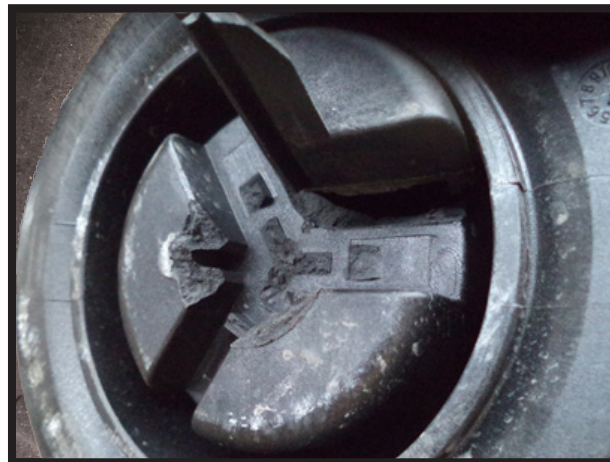
BROKEN LOWER PISTON CAUSED BY:

- INFLATING THE AIR SPRING WITHOUT SUPPORTING THE VEHICLE, CAUSING THE VEHICLE WEIGHT TO BE UNEVENLY DISTRIBUTED.
- INCORRECT MOUNTING OF THE LOWER PISTON.

PROPER INSTALLATION & INFLATION PROCEDURES MUST BE FOLLOWED TO AVOID PERMANENT DAMAGE TO THE PART. WARRANTY WILL BE VOID IF THESE PROCEDURES HAVE NOT BEEN FOLLOWED.

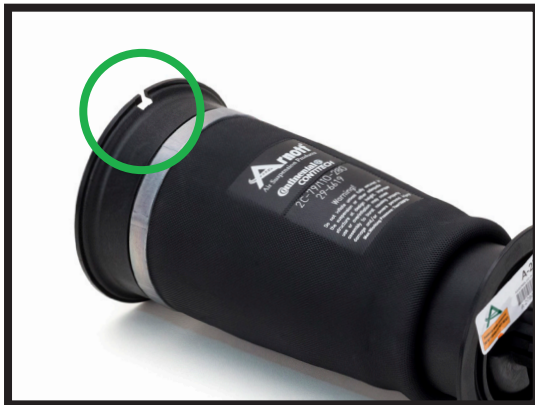
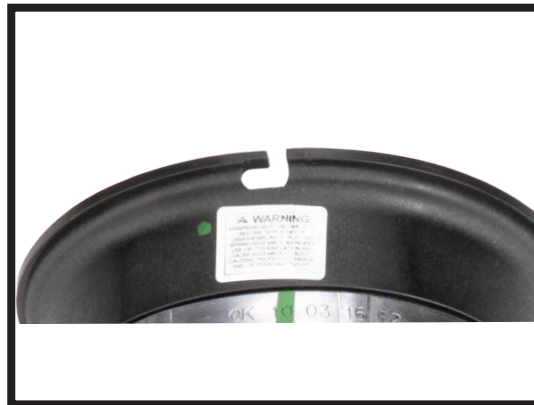
AIR LINE MUST BE ROUTED PROPERLY THROUGH THE NOTCH IN THE TOP MOUNT.

IMPROPER AIR LINE INSTALLATION CAN CAUSE THE AIR LINE TO GET STUCK BETWEEN THE AIR SPRING AND CHASSIS, MAKING IT IMPOSSIBLE TO DEFLATE THE AIR SPRING THROUGH THE AIR LINE.

BEFORE INFLATING THE AIR SPRING:

1. VERIFY THAT THE AIR LINE RUNS THROUGH THE TOP NOTCH OF THE AIR SPRING AND IS NOT STUCK BETWEEN THE AIR SPRING AND CHASSIS.
2. VERIFY THAT THE LOWER PISTON IS SEATED CORRECTLY AND THE LOCKING CLIPS ARE IN PLACE.
