SHAFTEC®

HP1648

Technical Information

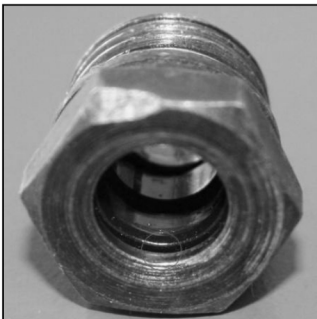
Figure 3

The pressure port fitting has an internal O ring (figure 3). It is important that this is checked following installation to ensure it is not damaged. If the fitting is leaking, it will need to be replaced or a new pipe assembly fitted.

It is important that any fluid leak from the pressure port fitting is corrected immediately. Fluid from the fitting can contaminate belts that run in the area around the steering pump. Damage to the pressure port thread caused by over tightening will invalidate the warranty.
