Diesel Engine Oil Consumption

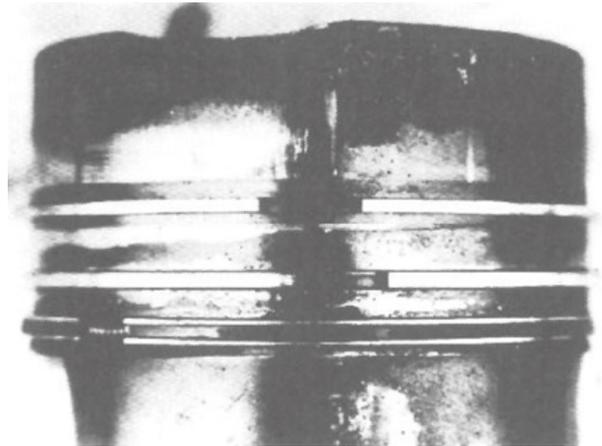
Fig. 1

Fig.1 Cylinder bore polishing arises from the excessive deposits of hard carbon on the piston top land (Fig. 1). Bore polishing tends to be self-evident. It is characterised by a bright, smooth "mirror-like" surface with elimination of the crosshatch-honing pattern (Fig. 2). The photographs show a cylinder liner and its mating piston, vividly illustrating the bore polishing condition present on the thrust faces.

The S.H.P.D. Oils previously mentioned and available from major oil companies are to be recommended for their ability to prevent cylinder bore polishing and show significant oil control advantage.
