LuK 0562

### Installation notice

#### Guide tube issues

Manufacturers :       Kia  
 Models :               Sportage  
                               Picanto  
 Engines :               Various

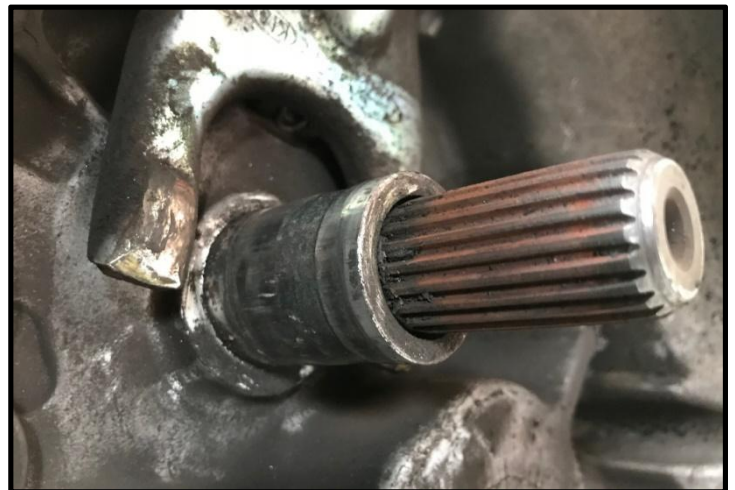
As with all vehicles using a release bearing and fork assembly it is crucial that the guide tube is in a servicable condition. On many of the Kia range the guide tube is an integral part of the bellhousing and can only be replaced as a complete assembly.

Excessive wear to the guide tube can result in heavy clutch operation, clearance problems or failure of the release bearing or fork.
