Service Information Cover assembly Versions MFZ 430 & MFZ 2 / 400 with preassembled releaser

3483 ... / 3488 ...

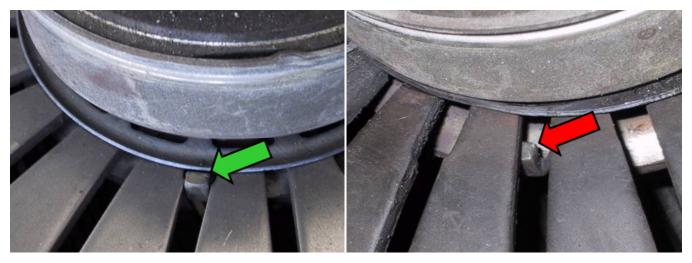
Fig. 1: Guide pin of release ring in its correct position

Fig. 2: Guide pin of release ring incorrectly seated -The pin slipped under the diaphragm spring

The correct position of the guide pins (Fig. 1) is between the recesses of the diaphragm spring tips. If one of these guide pins slips under the diaphragm spring tips due to improper handling / incorrect transportation eccentric / awry releaser contact will occur and inevitably cause premature failure. Any shock during transportation or handling prior to installation can force the releaser out of its centered position. This position is needed to ensure correct operation (Fig. 2).

Make sure to verify the correct position of the releaser prior to installation to avoid such damage.
