**Certified Automotive Parts Association**

**Vehicle Test Fit Report**

**Report Number:  
VWGF15FR1/VTF B/20150224**

Date: 2015 February 24 Report Number: VWGF15FR1/VTF B/20150224  
 Manufacturer Part #: VWGF15FR1 Manufacturer: Gordon Auto Body Parts Co., Ltd.  
 Car Company Service Part Application: Volkswagen Golf Gen 7, 14-16  
 (CCS) Part #: 5G0821106A

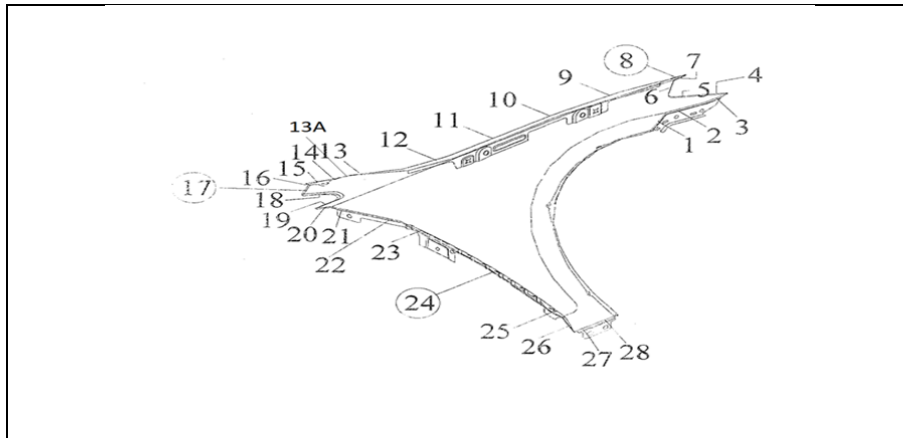
CCS Part	Conforming
Mfr. Part 1	Conforming
Mfr. Part 2	Conforming

No Best Fit difference between parts that were conforming for fit.

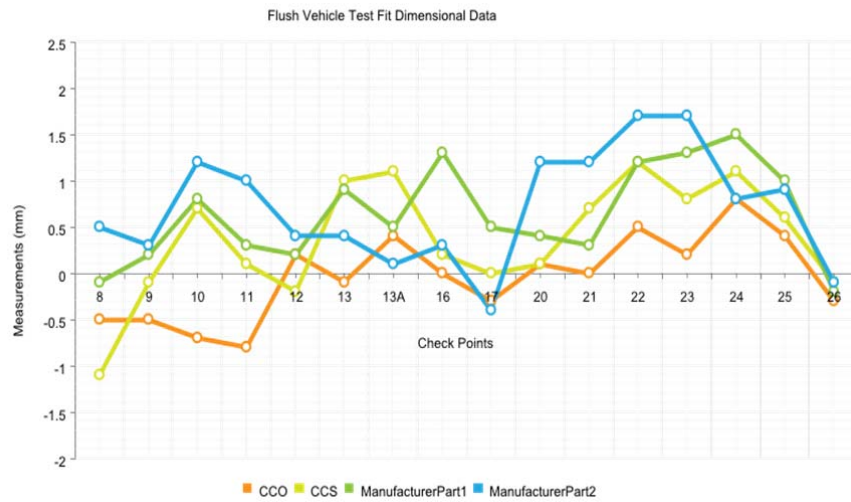
### Vehicle Test Fit Dimensional Data Plot

GAP				
	CCO Part	Mfr. Part 1	Mfr. Part 2	CCS Part
1				
2				
3				
4				
5				
6				
7				
8	3.5	3.2	2.9	3.4
9	3.5	3.1	3.1	3.2
10	3.5	3.2	3.4	3.2
11	3.2	3.2	3.7	2.8
12	2.7	3.2	3.6	3.1
13	2.6	3.0	3.6	3.7
13A	4.3	3.4	3.8	3.8
14				
15				
16	2.4	2.9	2.9	2.7
17	2.5	2.3	2.7	3.2
18				
19				
20	3.7	3.6	3.2	3.2
21	3.8	4.1	3.6	3.6
22	3.8	5.0	4.8	3.9
23	3.8	4.8	4.8	4.0
24	3.9	4.1	4.3	3.7
25	3.9	3.5	4.2	3.1

FLUSH				
	CCO Part	Mfr. Part 1	Mfr. Part 2	CCS Part
1				
2				
3				
4				
5				
6				
7				
8	<b>-0.5</b>	<b>-0.1</b>	<b>0.5</b>	<b>-1.1</b>
9	<b>-0.5</b>	<b>0.2</b>	<b>0.3</b>	<b>-0.1</b>
10	<b>-0.7</b>	<b>0.8</b>	<b>1.2</b>	<b>0.7</b>
11	<b>-0.8</b>	<b>0.3</b>	<b>1.0</b>	<b>0.1</b>
12	<b>0.2</b>	<b>0.2</b>	<b>0.4</b>	<b>-0.2</b>
13	<b>-0.1</b>	<b>0.9</b>	<b>0.4</b>	<b>1.0</b>
13A	<b>0.4</b>	<b>0.5</b>	<b>0.1</b>	<b>1.1</b>
14				
15				
16	<b>0.0</b>	<b>1.3</b>	<b>0.3</b>	<b>0.2</b>
17	<b>-0.3</b>	<b>0.5</b>	<b>-0.4</b>	<b>0.0</b>
18				
19				
20	<b>0.1</b>	<b>0.4</b>	<b>1.2</b>	<b>0.1</b>
21	<b>0.0</b>	<b>0.3</b>	<b>1.2</b>	<b>0.7</b>
22	<b>0.5</b>	<b>1.2</b>	<b>1.7</b>	<b>1.2</b>
23	<b>0.2</b>	<b>1.3</b>	<b>1.7</b>	<b>0.8</b>
24	<b>0.8</b>	<b>1.5</b>	<b>0.8</b>	<b>1.1</b>
25	<b>0.4</b>	<b>1.0</b>	<b>0.9</b>	<b>0.6</b>

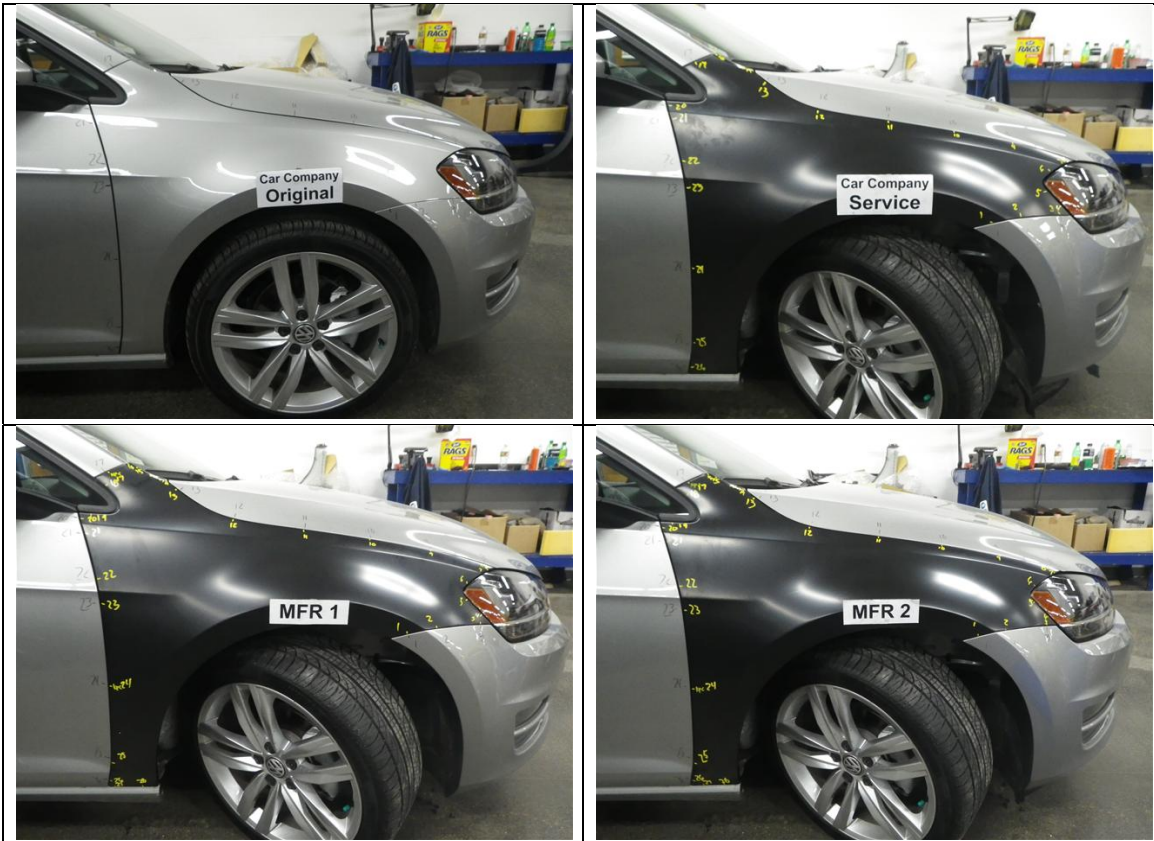
### VTF Photos

<b>CCS Part</b>	<p>Conforming</p>   <p>Foam rubber present on part:      No</p>	
<b>Mfr. Part 1</b>	<p>Conforming</p>   <p>Foam rubber present on part:      No</p>	
<b>Mfr. Part 2</b>	<p>Conforming</p>   <p>Foam rubber present on part:      No</p>
