VOLKSWAGEN
MULTIVAN/ CARAVAN/
TRANSPORTER

AC SYSTEM NOT COOLING/
NOT FUNCTIONING

VOLKSWAGEN T5 FULLY AUTOMATIC AC SYSTEM

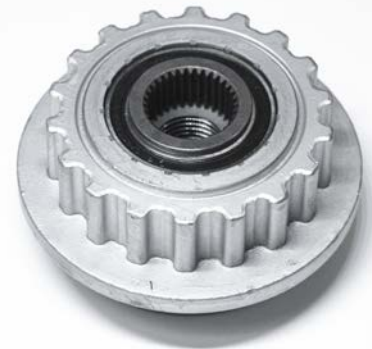
Photo 1

Damaged freewheel - Poor maintenance of the power steering pump and the air condition compressor causes damages to the GATES clutch (torn or cracked teeth).

- Make sure that the GATES clutch does not have any visual damages.
- Make sure that the overload protection does not prevent the compressor from turning the freewheel. By movement or blocks in either direction, replace the freewheel with OT no. 070 903 201 C (photo 1).
- Do not replace a fully functioning AC compressor when the freewheel is defective.
- Replace the damaged GATES clutch with OT no. 070 903 327 (see photos 2 & 3).
- Check if sleeves and mounting dowels on the bracket are worn. Furthermore, check if bracket dimensions are accurate.
- By measurement of 60 mm +/- 5.5 mm (measured without sleeves), replace bracket with OT no. 070 260 885 A.
