## Note on changing the oil filter

AZQ, BME, BZG

Seat Ibiza 1.2, Cordoba 1.2

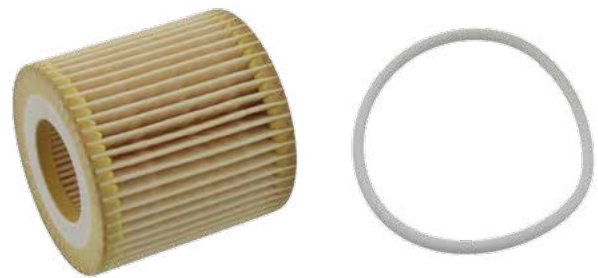
**SWAG no. 30 92 3468**

Repl. no. 03D 198 819 A
