SWAG 11 10 3197, 33 10 0153

To Fit:

various BMW, MINI, Peugeot,
Citroën and DS models.

Thermostat with housing, seal and temperature switch

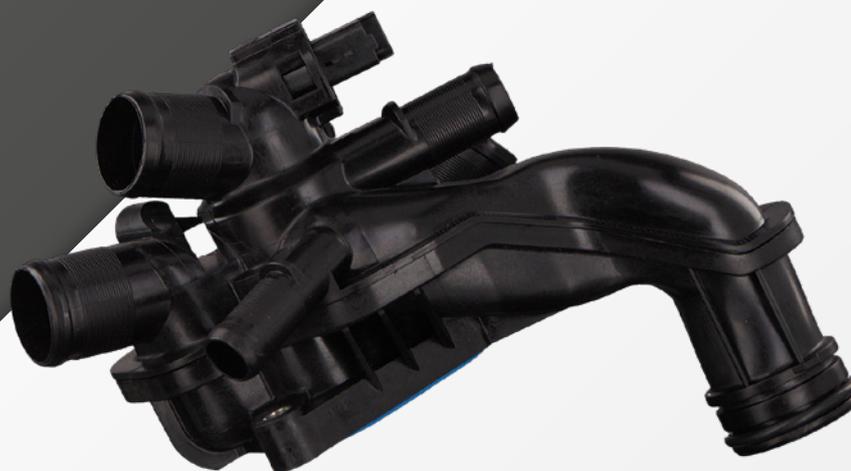
The thermostat incorporated in the coolant outlet housing becomes stuck in the 'open' position, resulting in the engine failing to reach operating temperature.

The thermostat incorporated in the coolant outlet housing becomes stuck in the 'closed' position, causing the engine to overheat.

The original polyamide material used, ages under the influence of constant engine heating, cooling cycles and vibration. The thermostat housing can distort or crack, leading to coolant leaks.

Due to the issues and symptoms listed above, the vehicle manufacturer has modified the design of the thermostat housing. The updated design benefits from an electronically-controlled thermostat, a reinforced structure, and a new configuration of the sensors - which may require an additional 2 x 2-way connector, subject to original vehicle equipment.

Therefore, diagnose and identify any fault codes which cause the warning lamps to illuminate. Replace the faulty coolant thermostat housing, fill the cooling system with fresh coolant, and bleed the air from the system.

Note: When replacing the thermostat housing, check all other coolant pipes for their condition and replace as necessary.
