Technical Bulletin

Silicon Carbide Seals

Why it's not a leak on your new water pump.

TB0001

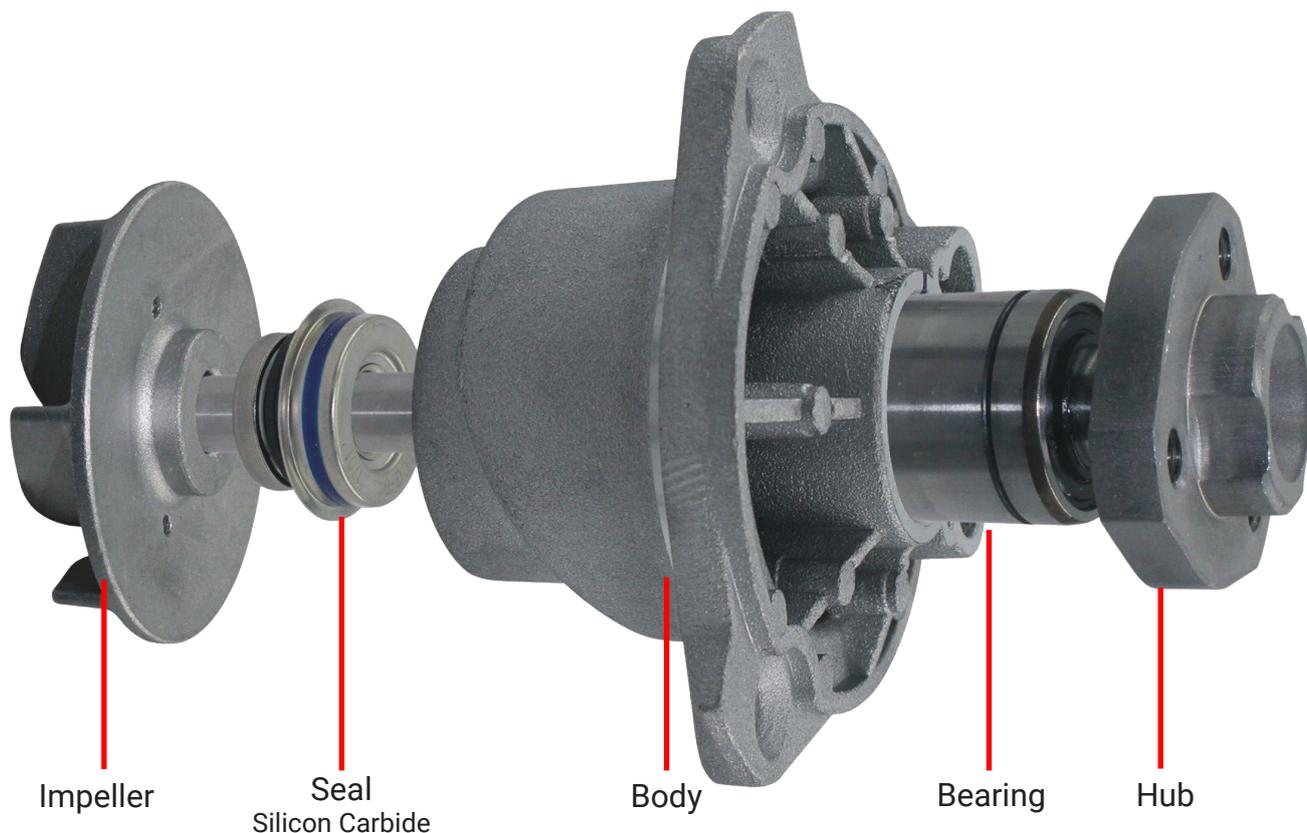
Silicon Carbide seals require the addition of coolant and heat to help create the seal. This is only possible when the water pump is installed and the engine is running. It is normal to see a trickle of coolant coming from the breather holes in the casting around the bearing area. This will only last a short time until the permanent seal is made.

Misdiagnosis has seen the unnecessary/premature replacement of new water pumps.
