KIA PICANTO CLUTCH CABLE INSTALLATION INFORMATION

Issue Date: 03/04/18 Issue Number: CATB0008F

APPLICATION: Kia Picanto 1.0, 1.1 (2004 > 2007)

APPLICABLE REFERENCES: FK1495

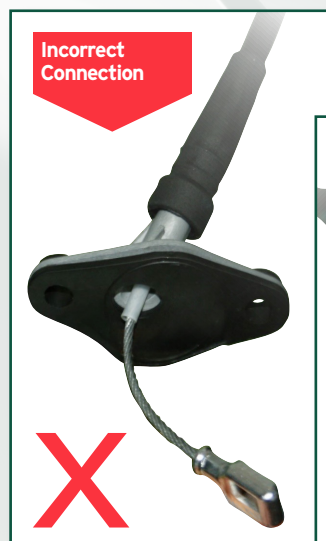
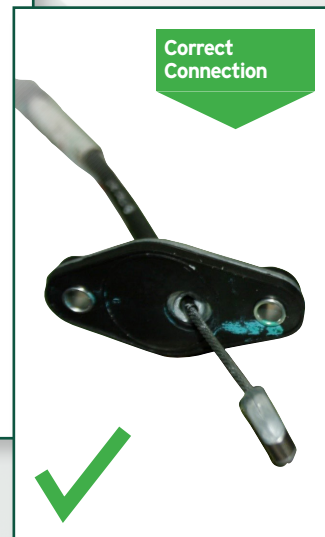
FAILED CABLE DUE TO INCORRECT FITMENT OF FK1495

If the connection is installed 180° out (upside down) this will result in the inner wire facing the opposite direction and therefore it will have to bend to fit the clutch pedal.

This will result in the inner wire cutting into the conduit culminating in the failure of the inner wire and the subsequent failure of the clutch cable.

When installing the Clutch Cable on a Kia Picanto 2004 > 2007 it is essential that the connection to the bulkhead is installed correctly.

The cable has been manufactured to go through the bulkhead at a set angle so that when fitted to the clutch pedal a smooth in-line operation will be achieved.

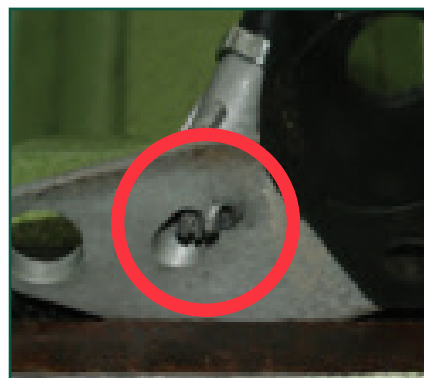
If the flange is fitted in wrong way (rotation of 180°), the wire rope will have to bend to fit on the pedal. This will induce rapid wear and failure of the cable.

Please Note: evidence of the cable being installed incorrectly will invalidate the warranty.
