## febi 39888, 39890 45931, 102278

Insert shaft

**To Fit:** Volkswagen Transporter T5

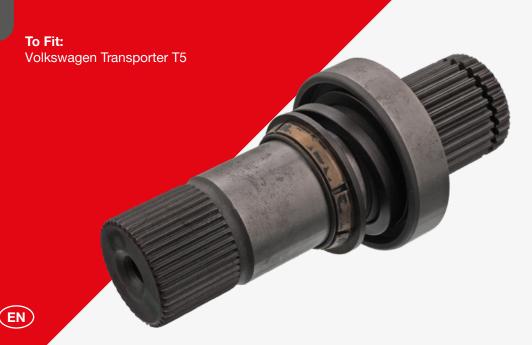
Clonking noise when pulling away or complete loss of drive.

The clonking noise - or loss of drive - is due to the excess wear between the connecting splines of the right insert shaft and the driveshaft. With the vehicle raised, inspect the area of the right-hand driveshaft. Rust stains can usually be found between the insert shaft and the driveshaft due to a lack of lubrication. As a result, the splines of the shafts will have become very worn and will no longer mesh together to drive the wheel.

In addition, the grease applied to the joint - when the vehicle was first manufactured - can leak or dry out over time. Failure could have also been caused during the removal and repair of the transmission if fresh grease had not been applied to the connecting splines during reinstallation e.g. during a clutch replacement.

Drain the transmission oil and remove the right-hand front wheel. Remove the worn driveshaft and inspect.

Using a suitable counter hold tool - to stop the insert shaft from turning - loosen the retaining bolt.

Remove the insert shaft from the transmission and inspect for any broken parts (Note: it is common for the brass ring to fracture causing remains to be left inside the differential). Remove all broken metal fragments, as necessary, then remove the driveshaft oil seal.

Apply a high temperature multi-purpose EP grease to the mating surfaces of the insert shaft and driveshaft. Then install the new driveshaft assembly and tighten all fixings to the manufacturer's recommended tightening settings.
