# 10155400

# CHRYSLER, MERCEDES

GASOLINA

1 **81050800** M11X1.50X141(8)

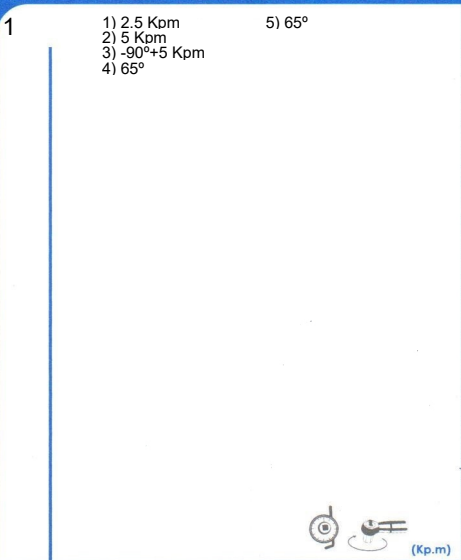
1 NO (Kp.m) RETIGHTENING

TORQUE SEQUENCE

LOOSEN 90° AND TIGHTEN BOLT BY BOLT RESPECTING THE SPECIFIED TORQUE AND ORDER  
AFLOJAR 90° Y APRIAR TORNILLO A TORNILLO CON EL PAR Y ORDEN ESPECIFICADOS  
LOOSEN ALL THE BOLTS  
AFLOJAR TODOS LOS TORNILLOS  
RUN THE ENGINE UNTIL TOTAL OPENING OF THE THERMOSTAT  
LET THE ENGINE COOL DOWN FOR 4 HOURS (WITH OPEN BONNET)  
OPEN THE CAP OF THE EXPANSION TANK OF THE WATER COOLING CIRCUIT  
RODAR EL MOTOR HASTA LA APERTURA TOTAL DEL TERMOSTATO  
DEJAR ENfriAR EL MOTOR CUATRO HORAS (CAPOT ABIERTO)  
ABRIR EL TAPON DEL VASO DE EXPANSION DEL CIRCUITO DEL AGUA DE REFRIGERACION

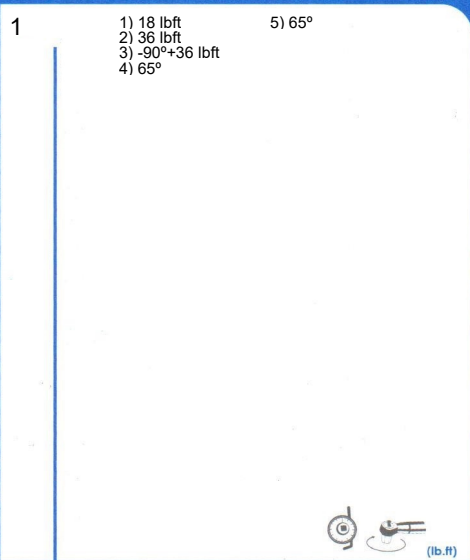
1 NO (lb.ft) RETIGHTENING
