24466 / 24467

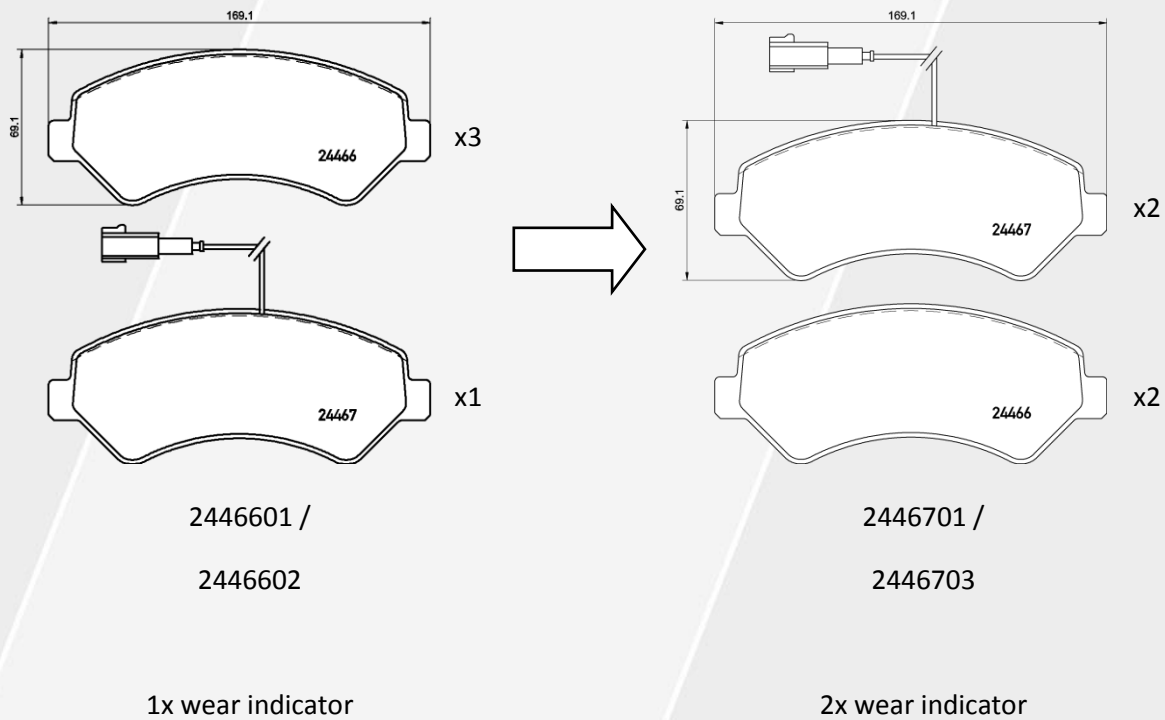
For the references 2446601 and 2446602 Fiat have changed their corresponding OES references from one wear indicator to two wear indicators per set. Not used wear indicators have to be simply cut off during assembly.

2446601 → 2446701

2446602 → 2446703

Existing stock of 2446601 and 2446602 can be sold out. Please take care that only vehicles equipped with one wear indicator can use 2446601/2446602.

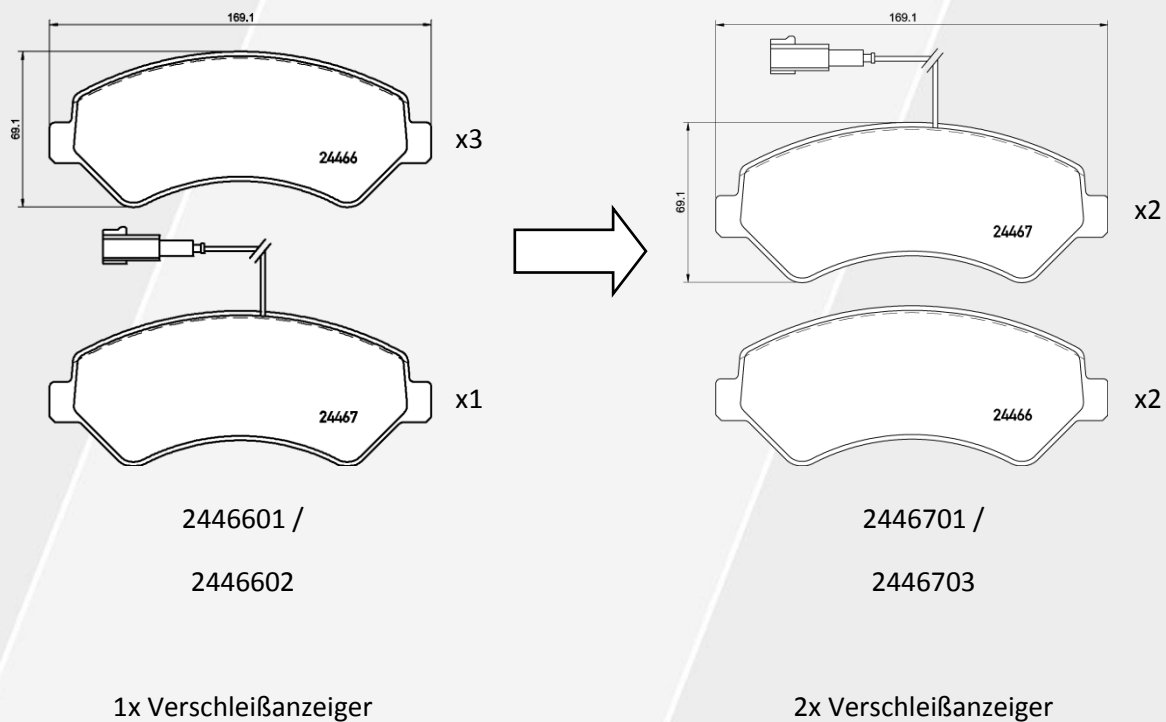
Für die Artikel 2446601 und 2446602 hat Fiat die entsprechenden OES Artikel von einem auf zwei Verschleißanzeiger pro Belagsatz umgestellt. Nicht benötigte Verschleißanzeiger können während der Montage einfach abgeschnitten werden.

2446601 → 2446701

2446602 → 2446703

Noch existierender Bestand kann verkauft werden. Bitte achten Sie während der Montage darauf, dass nur Fahrzeuge mit einem Verschleißanzeiger die Artikel 2446601/2446602 nutzen können.
