febi

Tip

Avoid Complaints

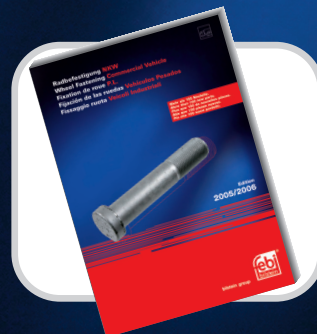
by only combining wheel bolts together with wheel nuts in conjunction with identical surface coatings. When using a silver-coloured Dacromet-coated wheel nut with a black phosphate-coated wheel bolt, the surface of the wheel bolt can be destroyed and thus, the corrosion protection no longer retains its effect. With different surfaces, the variation of the friction values and the preload force is considerably greater than when the same surface is used. As such, a flawless placement of the nut can probably no longer be guaranteed.

Make the right combinations!

For example, Dacromet-coated in silver

febi No. 12873 Wheel bolt

febi No. 07663 Wheel nut

For example, phosphate-coated in black

febi No. 03740 Wheel bolt

febi No. 04029 Wheel nut
